Recommendations for Managing the City of Gloucester's Compost Facility

Dogtown Advisory Committee
September 2018

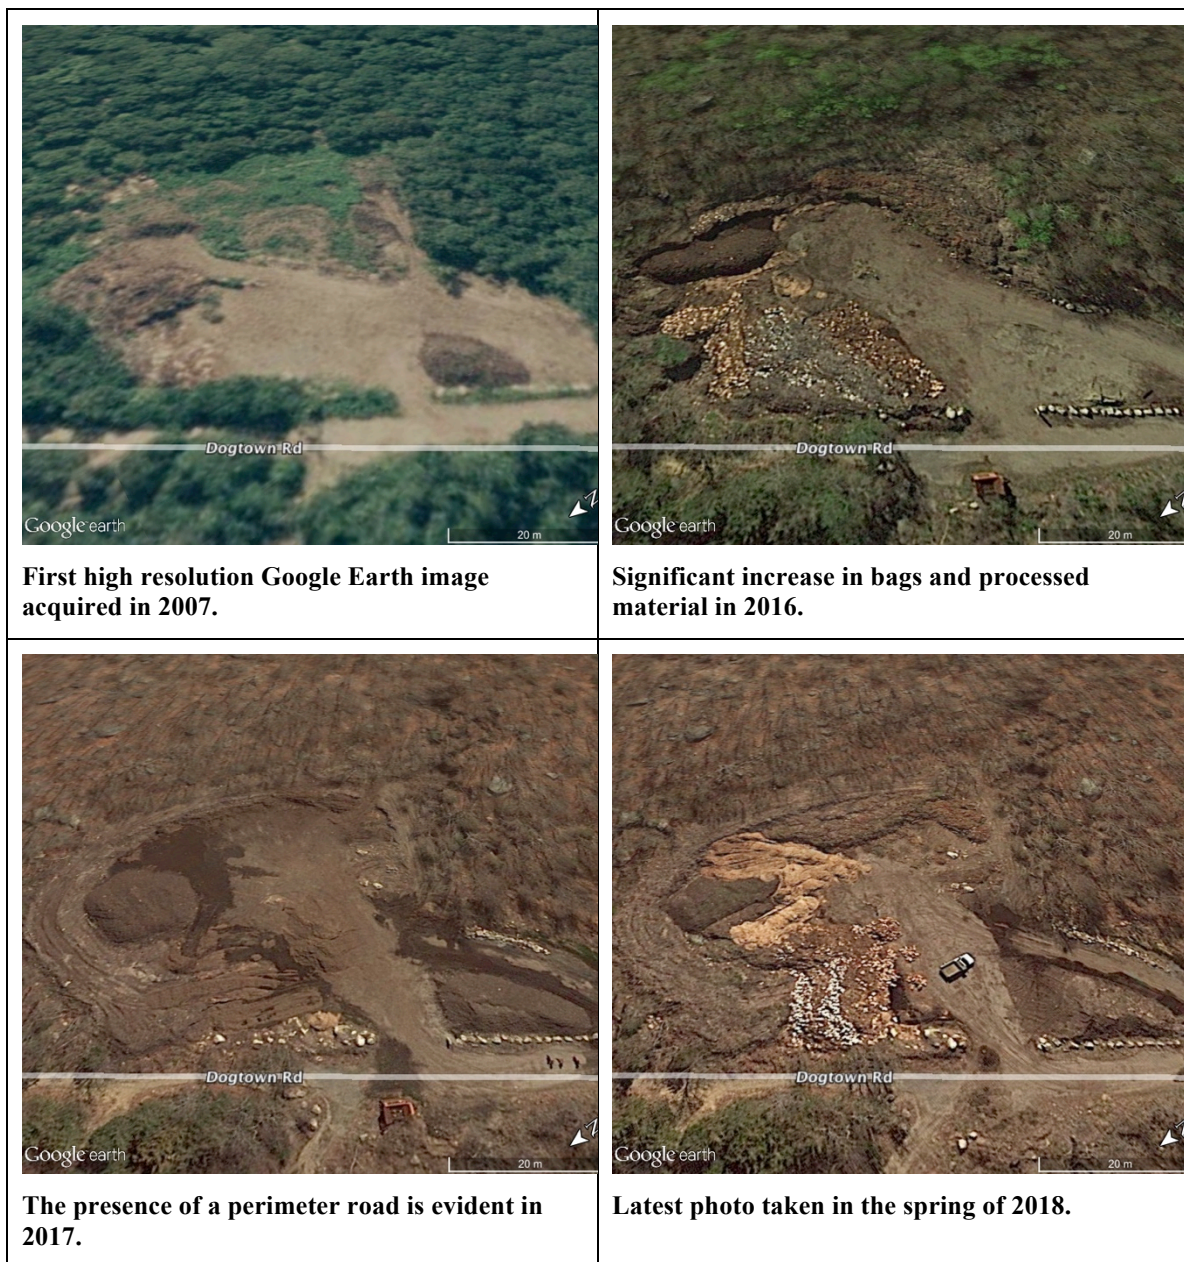
The Compost Facility is located south of Dogtown Road at the entrance to Historic Dogtown. Figure 1 shows changes in the footprint of the facility as seen in Google Earth imagery beginning in 2005. Although the physical extent of the site does not seem to have changed significantly over this period of time, the volume of material has visibly increased. Figure 2 shows the current height of brush piles along the north and east boundaries of the facility. The volume of the site is increasing because the amount of raw material received exceeds the amount of compost being removed. Given restrictions limiting the area of the Compost Facility, this increase in volume cannot be sustained indefinitely. Eventually the amount of material will have to be limited, or other steps will have to be taken.

Figure 1 Google Earth images showing changes in the compost facility over the past decade.

The DAC is recommending both short and long-term steps for improving management of the Compost Facility with a focus on 1) eliminating non-organic materials; 2) managing and reducing invasives and 3) reducing the overall load by using private facilities to manage yard waste.

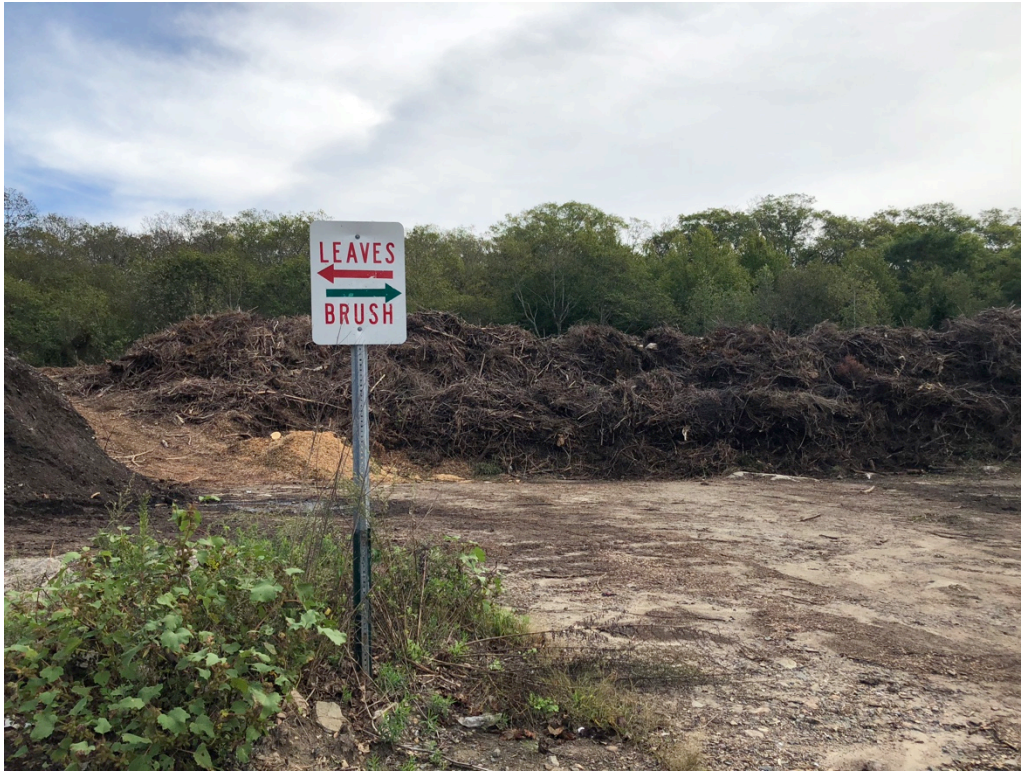
Figure 2 Ground view of compost facility looking north toward brush piles.

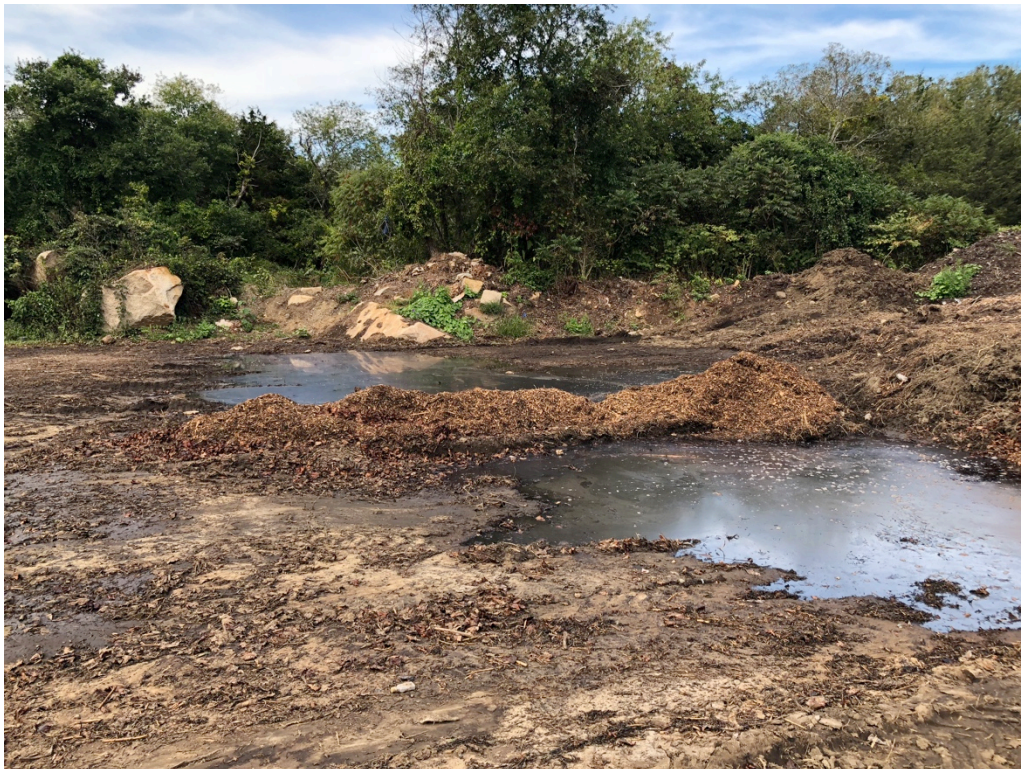
Figure 3 Pools of standing water are not uncommon at the site.

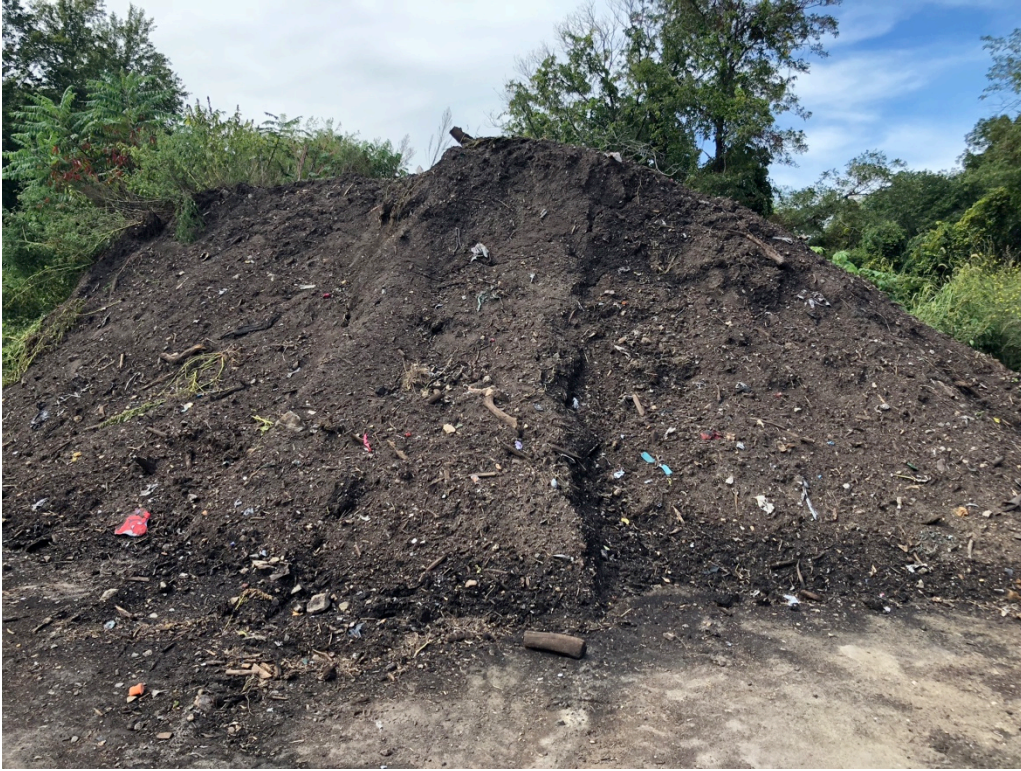
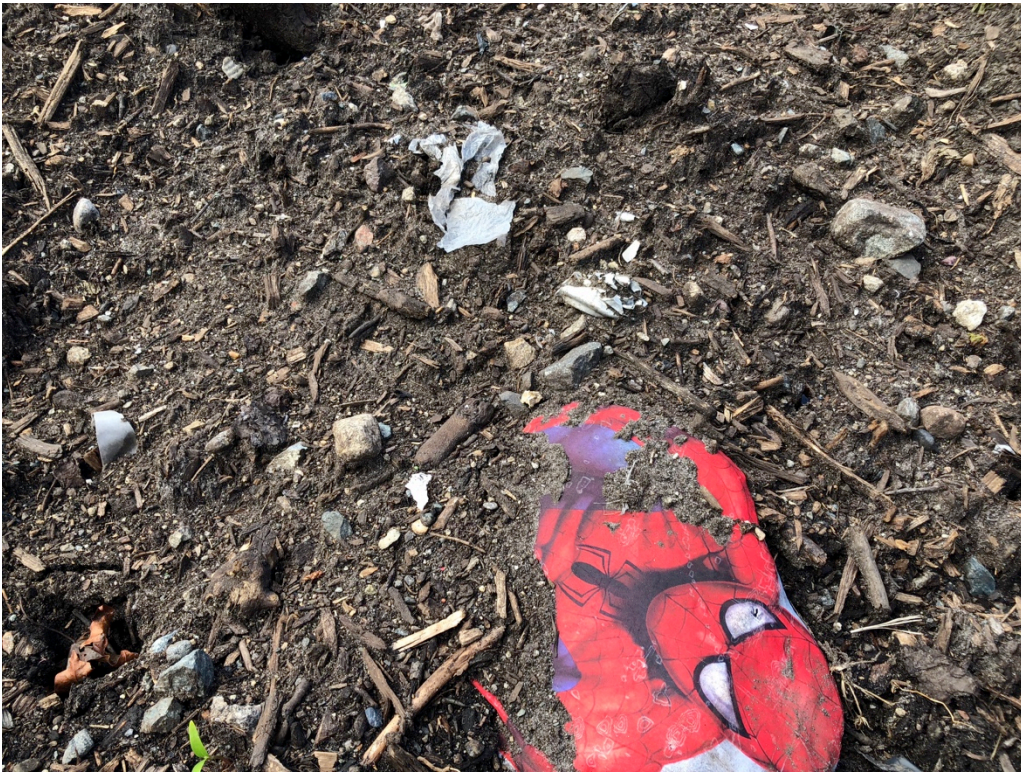
Perhaps most noticeable, a significant amount of non-organic material including plastic and metal is present in the large pile of compost that is made available for public use (Figure 4).

Figure 4 Compost available to the public (top). Close up showing presence of non-organic components (bottom).

Since the public gathers compost from the Compost Facility, street sweepings should not be disposed of there. If this is not feasible, the DAC recommends that signage be posted near the finished compost explaining these restrictions to citizens and DPW personnel who might be gathering materials for use off site.

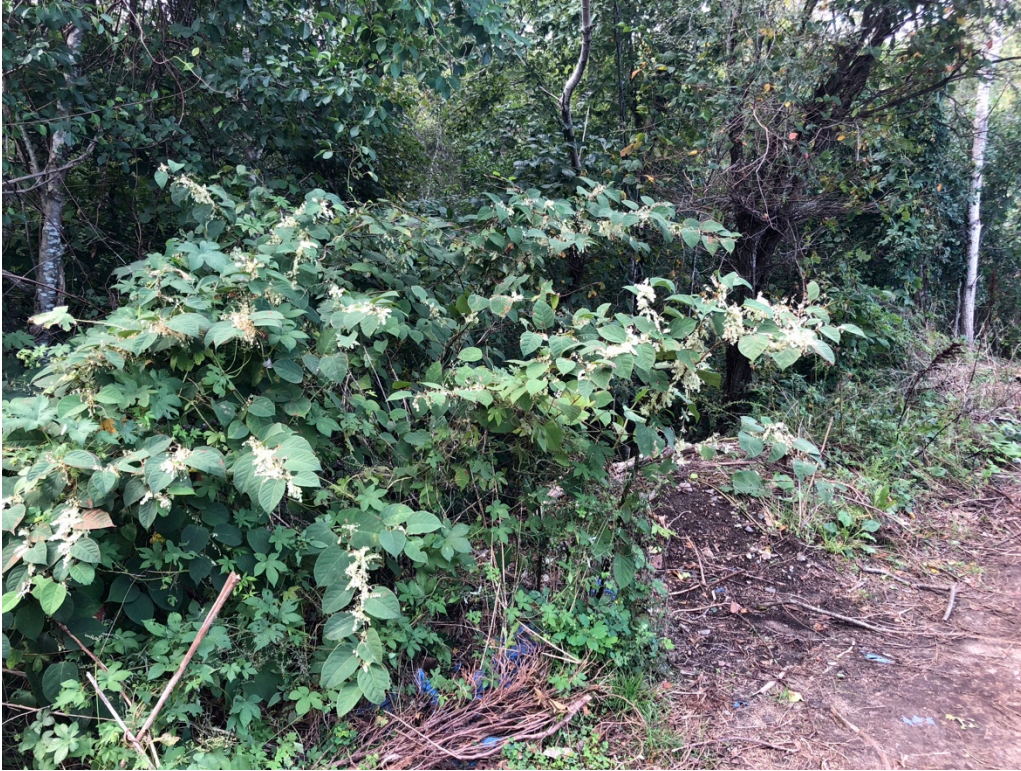
Incoming compost materials include non-native plant species that are considered “invasives” because of their ability to out-compete native species, and because many of these invasives lack predators that would otherwise control their spread. As a result, the Compost Facility acts as a “hub” for the spread of these invasives in Dogtown as they reproduce from seeds or fragments (Figure 5).

Figure 5 Japanese knotweed (*Fallopia japonica*) at the Compost Facility

We recommend that DAC work with the DPW to determine how best to handle invasives in Gloucester, and work together to develop some brief educational signage and web site materials to educate the public.
